# Access Compliance Report Public Rights-of-Way (Curb Ramps)

Main Street: **NORWOOD\_PARK** Cross Street: **PROSPECT\_AVE** Location: **SE**

ADA ID: **RPRK211011120109** Ramp Type: **Type 1 - Perpendicular Diagonal** Initial Pass/Fail: **Fail** Overall Compliance: **No** Severity Score: **32**

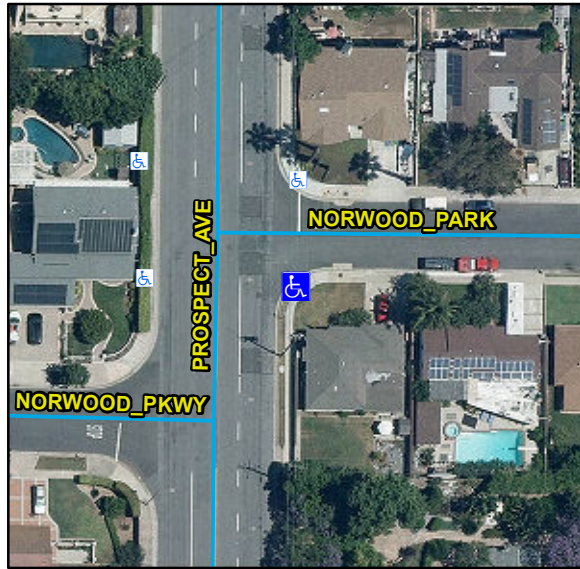
| Compliance | Description | Data | Compliance | Description | Data |
|---|---|---|---|---|---|
| <b>No</b> | Ramp Run Slope (%) | <b>13.3</b> | <b>N/A</b> | Flare Slope LT (%) | <b>N/A</b> |
| <b>No</b> | Ramp Cross Slope (%) | <b>3</b> | <b>N/A</b> | Flare Traversable LT | <b>N/A</b> |

**Remove & Replace Curb Ramp With Two New Directional Ramps or Equivalent.**

**R304.2.2, R304.5.3, STD 1115**
