# Access Compliance Report Public Rights-of-Way (Curb Ramps)

Main Street: HOWLAND\_WAY Cross Street: BIGELOW\_PKWY Location: SW

ADA ID: RPRK211011121725 Ramp Type: Type 1 - Perpendicular Diagonal Initial Pass/Fail: Fail Overall Compliance: No Severity Score: 16

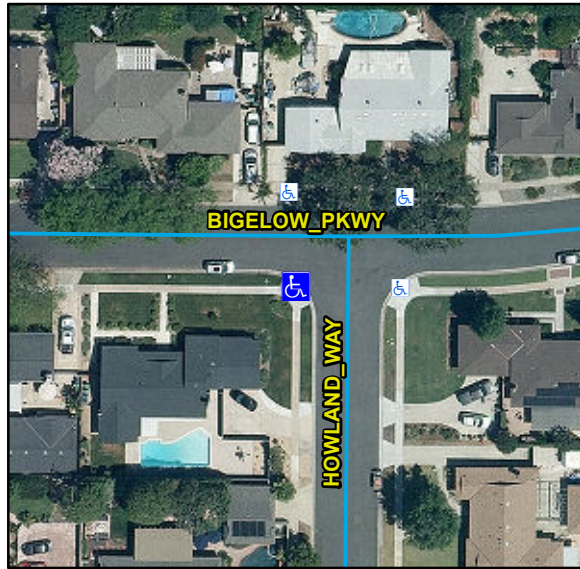
| Compliance | Description | Data | Compliance | Description | Data |
|---|---|---|---|---|---|
| No | Ramp Run Slope (%) | 9.8 | N/A | Flare Slope LT (%) | N/A |
| No | Ramp Cross Slope (%) | 2.3 | N/A | Flare Traversable LT | N/A |

Remove & Replace Curb Ramp With Two New Directional Ramps or Equivalent.

R304.2.2, R304.5.3, STD 1115
