# Access Compliance Report Public Rights-of-Way (Curb Ramps)

Main Street: BIGELOW\_PKWY Cross Street: HOWLAND\_WAY Location: SE

ADA ID: RPRK211011121916 Ramp Type: Type 1 - Perpendicular Diagonal Initial Pass/Fail: Fail Overall Compliance: No Severity Score: 15

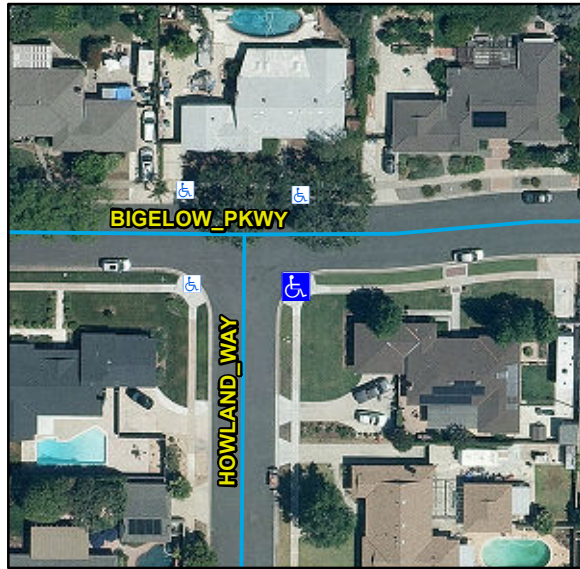
| Compliance | Description | Data | Compliance | Description | Data |
|---|---|---|---|---|---|
| No | Ramp Run Slope (%) | 9.1 | N/A | Flare Slope LT (%) | N/A |

Remove & Replace Curb Ramp With Two New Directional Ramps or Equivalent.

R304.2.2, STD 1115
