# Access Compliance Report Public Rights-of-Way (Curb Ramps)

Main Street: BIGELOW\_PKWY Cross Street: PROSPECT\_AVE Location: SE

ADA ID: RPRK211011122356 Ramp Type: Type 1 - Perpendicular Diagonal Initial Pass/Fail: Pass Overall Compliance: No Severity Score: 2

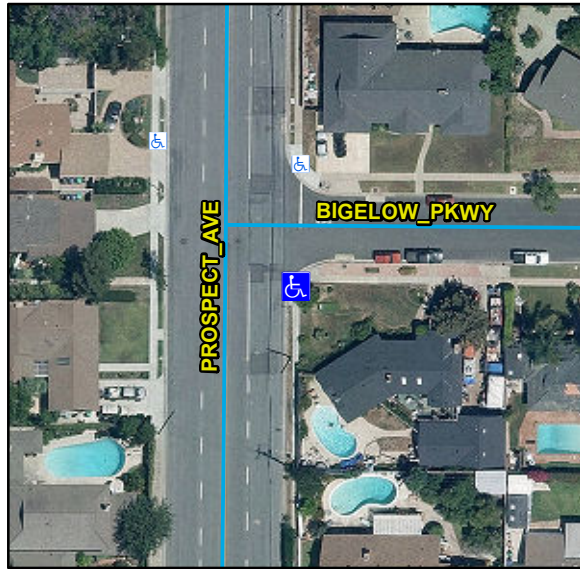
| Compliance | Description | Data | Compliance | Description | Data |
|---|---|---|---|---|---|
| No | Ramp Cross Slope (%) | 2.3 | N/A | Flare Traversable LT | N/A |
| Yes | Gutter Ponding | No | No | Curb Slope | 7.6 |

Remove & Replace Curb Ramp With Two New Directional Ramps or Equivalent.

R304.2.2, R304.5.3, STD 1115
