# Access Compliance Report Public Rights-of-Way (Curb Ramps)

Main Street: BIGELOW\_PKWY Cross Street: HOLT\_AVE Location: SW

ADA ID: RPRK211011125802 Ramp Type: Type 7 - Directional 2 Initial Pass/Fail: Fail Overall Compliance: No Severity Score: 15

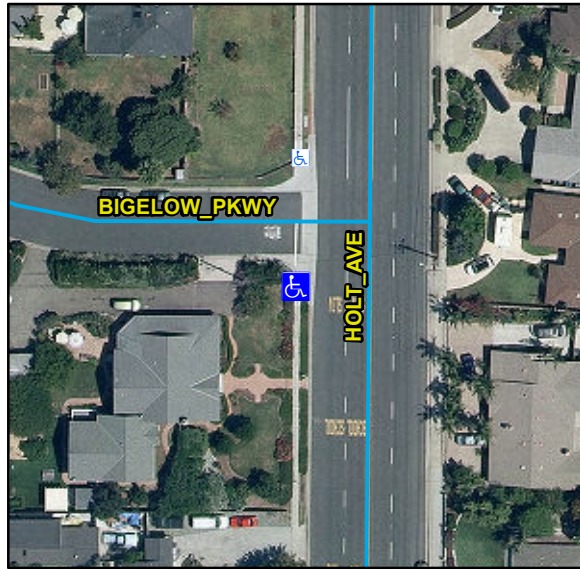
| Compliance | Description | Data | Compliance | Description | Data |
|---|---|---|---|---|---|
| No | Ramp Run Slope (%) | 10.9 | N/A | Flare Slope LT (%) | N/A |

Remove & Replace Entire Ramp.

R204.3, R304.2.2, STD 1115
