# Access Compliance Report Public Rights-of-Way (Curb Ramps)

| Main Street: BIGELOW_PKWY | | Cross Street: HOLT_AVE | | Location: | NW |
| ADA ID: RPRK211011130042 | Ramp Type: Type 7 - Directional 2 | Initial Pass/Fail: Fail | Overall Compliance: No | Severity Score: | 15 |

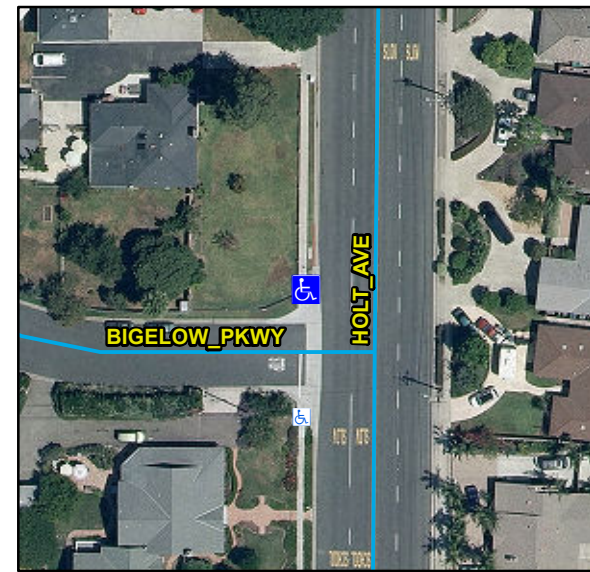
| Compliance | Description | Data | Compliance | Description | Data |
|---|---|---|---|---|---|
| No | Ramp Run Slope (%) | 11.8 | N/A | Flare Slope LT (%) | N/A |

**Remove & Replace Entire Ramp.**

**R204.3, R304.2.2, STD 1115**

Total Cost: \$ 3080

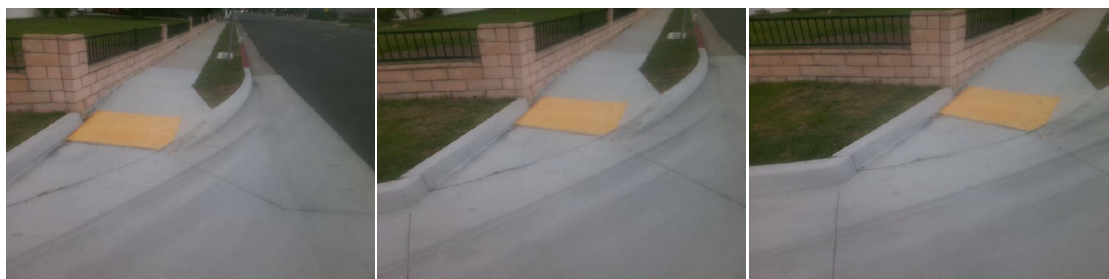
| Compliance | Description | Data | Compliance | Description | Data |
|---|---|---|---|---|---|
| N/A | Ramp Length (in) | 150 | N/A | Flare Type LT | |
| Yes | Ramp Width (in) | 60 | | | N/A |
| Yes | Ramp Cross Slope (%) | 1.8 | N/A | Flare Traversable LT | N/A |
