# Access Compliance Report Public Rights-of-Way (Curb Ramps)

Main Street: WELLINGTON\_AVE Cross Street: HOLT\_AVE Location: NW

ADA ID: RPRK211011130550 Ramp Type: Type 1 - Perpendicular Diagonal Initial Pass/Fail: Fail Overall Compliance: No Severity Score: 15

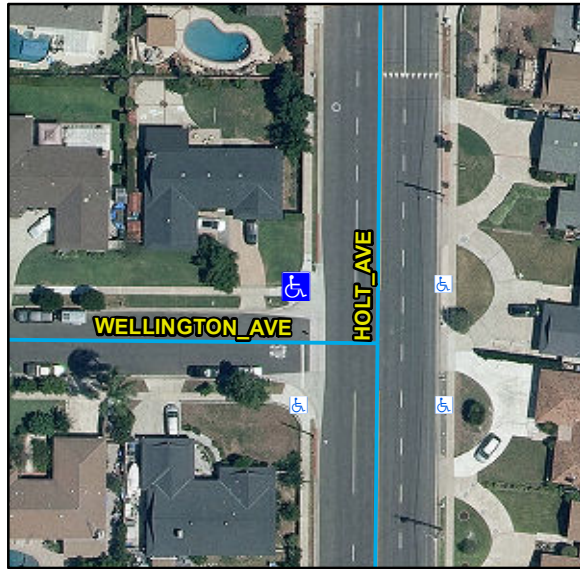
| Compliance | Description | Data | Compliance | Description | Data |
|---|---|---|---|---|---|
| No | Ramp Run Slope (%) | 9.3 | N/A | Flare Slope LT (%) | N/A |

Remove & Replace Curb Ramp With Two New Directional Ramps or Equivalent.

R304.2.2, STD 1115
