# Access Compliance Report Public Rights-of-Way (Curb Ramps)

Main Street: HOLT\_AVE Cross Street: VANDERLIP\_AVE Location: SW

ADA ID: RPRK211011131028 Ramp Type: Type 4 - Parallel Initial Pass/Fail: Fail Overall Compliance: No Severity Score: 16

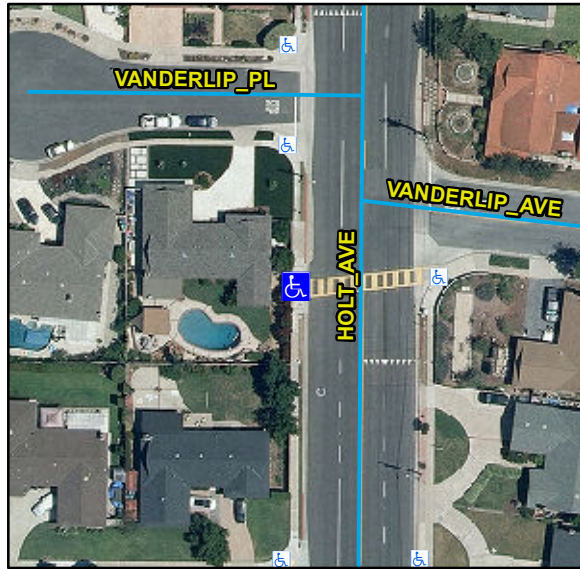
| Compliance | Description | Data | Compliance | Description | Data |
|---|---|---|---|---|---|
| No | Ramp Run Slope LT (%) | 9.3 | Yes | Ramp Run Slope RT (%) | 3.9 |
| No | Ramp Cross Slope LT (%) | 3.5 | Yes | Ramp Cross Slope RT (%) | 1.5 |

Remove & Replace Entire Ramp.

R304.3.2, R304.5.3, STD 1115
