# Access Compliance Report Public Rights-of-Way (Curb Ramps)

Main Street: HOLT\_AVE Cross Street: VANDERLIP\_PL Location: SW

ADA ID: RPRK211011131752 Ramp Type: Type 1 - Perpendicular Diagonal Initial Pass/Fail: Pass Overall Compliance: No Severity Score: 10

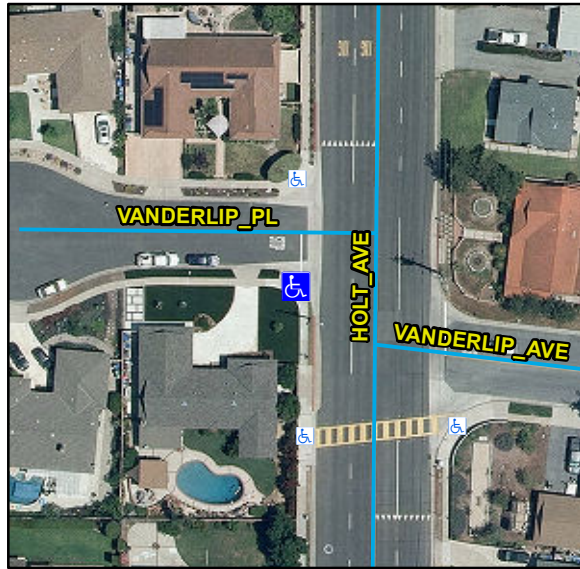
| Compliance | Description | Data | Compliance | Description | Data |
|---|---|---|---|---|---|
| Yes | Ramp Run Slope (%) | 6.2 | Yes | Flare Slope LT (%) | 3.7 |
| No | Landing Width (in) | N/A | Yes | Flare Slope RT (%) | 5.8 |
| No | Landing Run Slope (%) | N/A | N/A | Flare Traversable RT | Yes |
| No | Landing Cross Slope (%) | N/A | Yes | DWS Provided | Yes |

Remove & Replace Curb Ramp With Two New Directional Ramps or Equivalent.

R304.2.2, R304.2.1, R304.2.2-Perp, R304.3.2-Para, R304.5.3, STD 1115
