# Access Compliance Report Public Rights-of-Way (Curb Ramps)

Main Street: N/A Cross Street: HOLT\_AVE Location: W

ADA ID: RPRK211011134029 Ramp Type: Type 6 - Directional 1 Initial Pass/Fail: Fail Overall Compliance: No Severity Score: 2

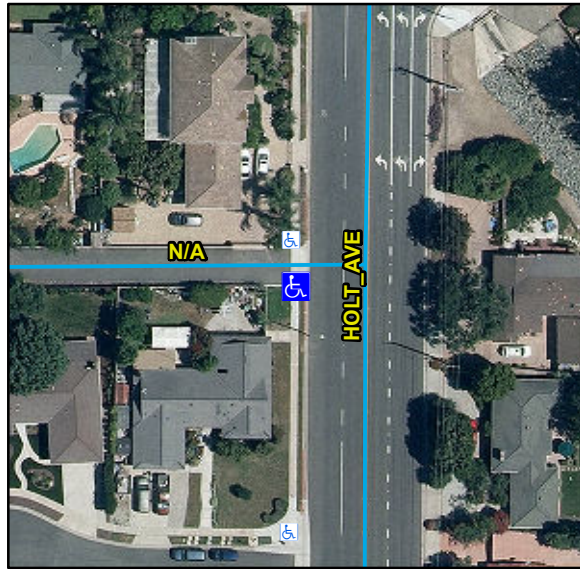
| Compliance | Description | Data | Compliance | Description | Data |
|---|---|---|---|---|---|
| No | Ramp Cross Slope (%) | 3.1 | N/A | Flare Traversable LT | N/A |

Possible Solutions:

Remove & Replace Entire Ramp.

R204.3, R304.5.3, STD 1115

\$ 3080
