# Access Compliance Report Public Rights-of-Way (Curb Ramps)

Main Street: N/A Cross Street: HOLT\_AVE Location: W

ADA ID: RPRK211011134217 Ramp Type: Type 1 - Perpendicular Initial Pass/Fail: Pass Overall Compliance: No Severity Score: 4

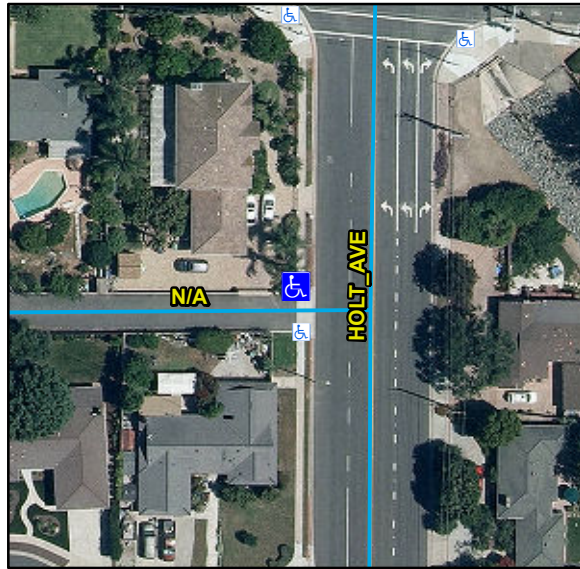
| Compliance | Description | Data | Compliance | Description | Data |
|---|---|---|---|---|---|
| No | Landing Cross Slope (%) | 2.1 | Yes | DWS Provided | Yes |

Remove & Replace Entire Ramp.

R204.3, R304.2.1, R304.5.3, STD 1115
