Access Compliance Report Public Rights-of-Way (Curb Ramps)

Main Street: GERSHON_PL **Cross Street:** 17TH_ST **Location:** SW

ADA ID: RPRK211011134620 **Ramp Type:**Type 1 - Perpendicular Diagonal Initial Pass/Fail: Pass **Overall Compliance:** No **Severity Score:** 10

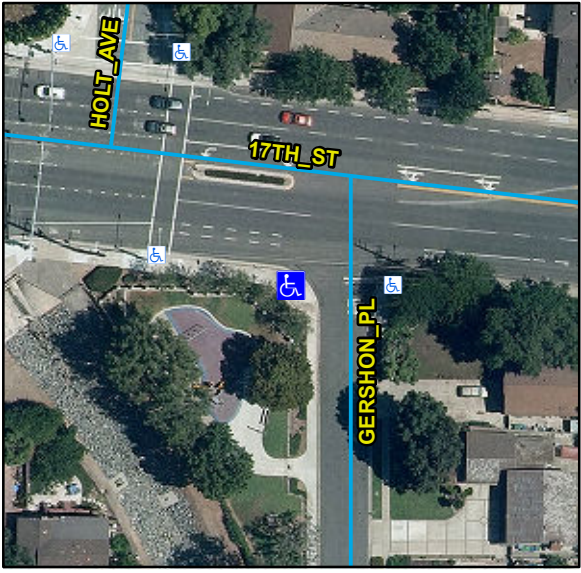
Compliance	Description	Data	Compliance	Description	Data
N/A	Ramp Length (in)	108	N/A	Flare Type LT	
Yes	Ramp Width (in)	48		Flare Slope LT (%)	4.8
Yes	Ramp Run Slope (%)	7.8	N/A	Flare Traversable LT	Yes
Yes	Ramp Cross Slope (%)	0.5	N/A	Flare Type RT	
N/A	Landing Present	Yes		Flare Slope RT (%)	6.5
N/A	Landing Length (in)	40	N/A	Flare Traversable RT	Yes
Yes	Landing Width (in)	48	Yes	DWS Provided	Yes
Yes	Landing Run Slope (%)	1.6	N/A	DWS Contrast	Yes
No	Landing Cross Slope (%)	2.5	Yes	DWS Length (in)	36
N/A	Landing Movement Obstructed?	No	Yes	DWS Full Width	Yes
	Landing Movement Type	N/A	Yes	DWS Offset Left (in)	0
N/A	Landing Shared	No	Yes	DWS Offset Right (in)	N/A
N/A	Clear Space	Yes	N/A	Marked Crosswalk 1	No
N/A	Clear Space To Crosswalk (in)	48	Yes	Marked Crosswalk 2	No
N/A	Marked Crosswalk 1	No		Crossing 1 Direction	E
	Crossing 1 Direction	E		Crossing 2 Direction	N
	Marked Crosswalk 1 Width (in)	N/A		Marked Crosswalk 2 Width (in)	N/A

N/A	Ramp Inside Crosswalk 1	N/A	Yes	Ramp Inside Crosswalk 2	N/A
	Crossing 1 Slope (%)	6.4		Crossing 2 Slope (%)	6.8
	Crossing 1 Cross Slope (%)	0.2		Crossing 2 Cross Slope (%)	0.1
Yes	Gutter Ponding	No	No	Curb Slope	6.6
Yes	Gutter Lip Height (in)	0		Road Run Slope (%)	0.6
No	Gutter Run Slope (%)	5.8		Road Cross Slope (%)	5.7
Yes	Gutter Cross Slope (%)	0.1			
Yes	Overall Surface Condition: Acceptable		Yes	Perp Joint Present	Yes
	Cross Gutter Present?	No		Spandrel Present?	No
	Replace Cross Gutter?	N/A		Replace Spandrel?	N/A

Possible Solutions:
Remove & Replace Curb Ramp With Two New Directional Ramps or Equivalent. Remove & Replace Gutter.
