# Access Compliance Report

## Public Rights-of-Way

### (Curb Ramps)

Main Street: IRVINE\_BLVD Cross Street: HOLT\_AVE Location: NW

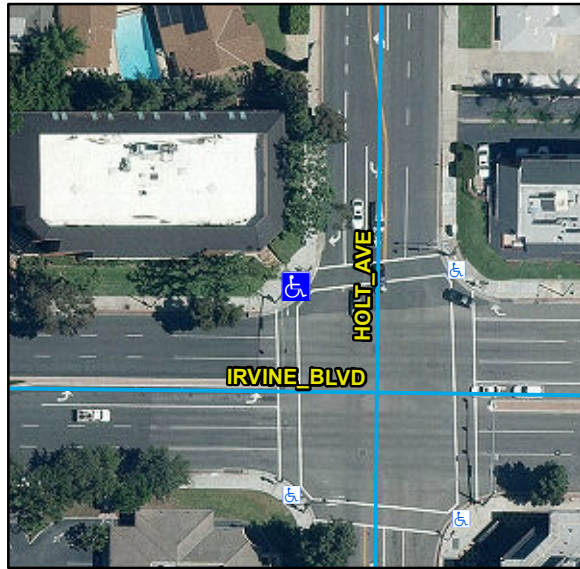
ADA ID: RPRK211011142008 Ramp Type: Type 1 - Perpendicular Diagonal Initial Pass/Fail: Fail Overall Compliance: No Severity Score: 2

| Compliance | Description | Data | Compliance | Description | Data |
|---|---|---|---|---|---|
| No | Ramp Cross Slope (%) | 3.5 | N/A | Flare Traversable LT | N/A |

**Remove & Replace Curb Ramp With Two New Directional Ramps or Equivalent.**

**R304.5.3, STD 1115**
