# Access Compliance Report Public Rights-of-Way (Curb Ramps)

Main Street: **HOLT\_AVE** Cross Street: **IRVINE\_BVD** Location: **NE**

ADA ID: **RPRK211011142609** Ramp Type: **Type 1 - Perpendicular Diagonal Initial Pass/Fail: Fail** Overall Compliance: **No** Severity Score: **2**

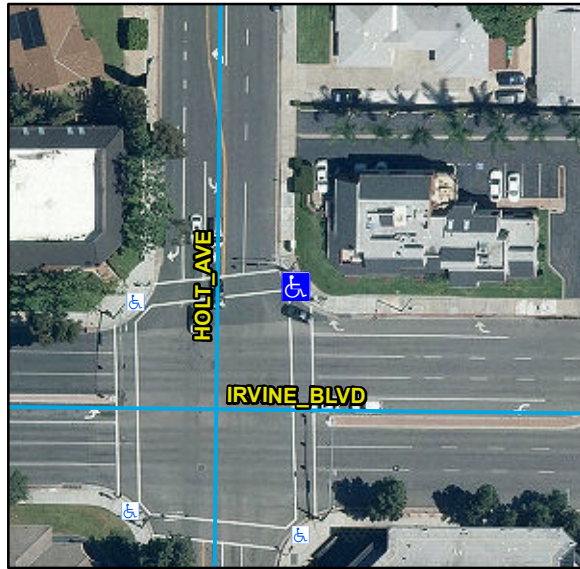
| Compliance | Description | Data | Compliance | Description | Data |
|---|---|---|---|---|---|
| <b>No</b> | Ramp Cross Slope (%) | <b>3.5</b> | <b>N/A</b> | Flare Traversable LT | <b>N/A</b> |

**Remove & Replace Curb Ramp With Two New Directional Ramps or Equivalent.**

**R304.5.3, STD 1115**
