# Access Compliance Report Public Rights-of-Way (Curb Ramps)

Main Street: CLARISSA\_LN Cross Street: WARREN\_AVE Location: SW

ADA ID: RPRK211011144545 Ramp Type: Type 1 - Perpendicular Diagonal Initial Pass/Fail: Pass Overall Compliance: No Severity Score: 10

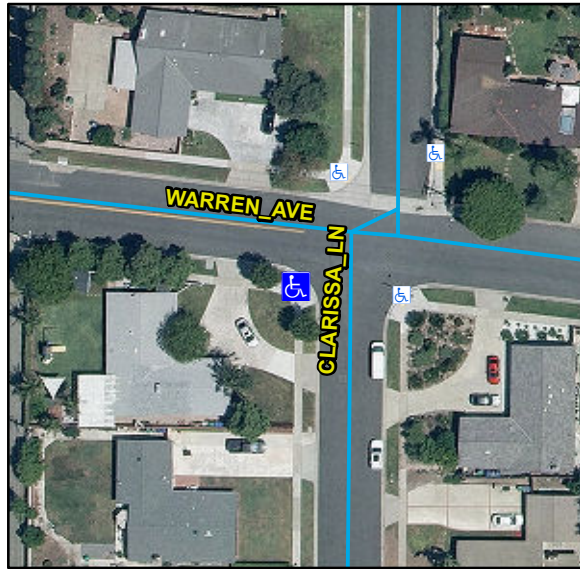
R304.2.2, R304.2.1, R304.2.2-Perp, R304.3.2-Para, R304.5.3, STD 1115

Remove & Replace Curb Ramp With Two New Directional Ramps or Equivalent.
