# Access Compliance Report Public Rights-of-Way (Curb Ramps)

Main Street: WASS\_ST Cross Street: NEWPORT\_AVE Location: SW

ADA ID: RPRK211011152254 Ramp Type: Type 1 - Perpendicular Diagonal Initial Pass/Fail: Fail Overall Compliance: No Severity Score: 15

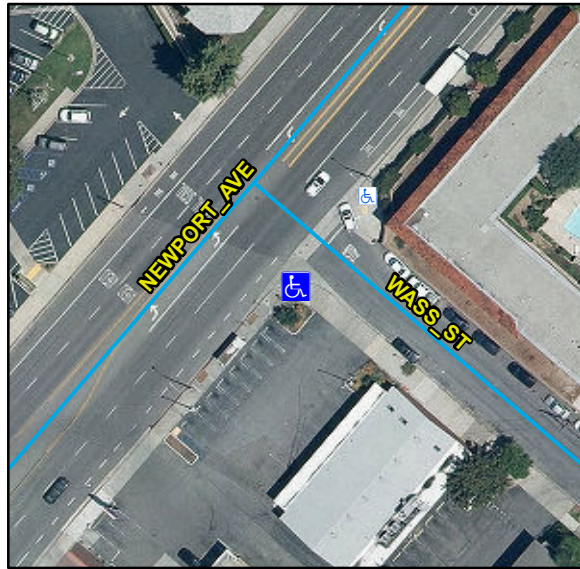
| Compliance | Description | Data | Compliance | Description | Data |
|---|---|---|---|---|---|
| No | Ramp Run Slope (%) | 8.5 | N/A | Flare Slope LT (%) | N/A |
| No | Gutter Lip Height (in) | 0.25 | | Road Run Slope (%) | 0.3 |

Remove & Replace Curb Ramp With Two New Directional Ramps or Equivalent.

R304.2.2, R302.7.2, STD 1115
