# Access Compliance Report Public Rights-of-Way (Curb Ramps)

Main Street: OLD\_FOOTHILL\_BLVD Cross Street: BARRETT\_LN Location: W

ADA ID: RPRK211011165758 Ramp Type: Type 4 - Parallel Initial Pass/Fail: Pass Overall Compliance: No Severity Score: 5

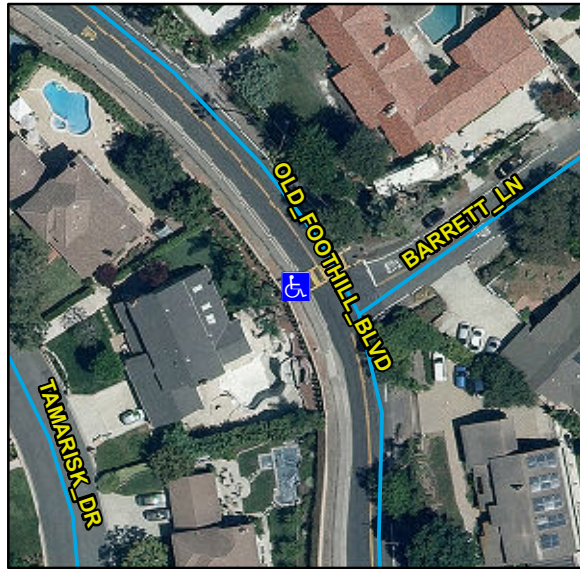
| Compliance | Description | Data | Compliance | Description | Data |
|---|---|---|---|---|---|
| No | Gutter Run Slope (%) | 10.1 | | Road Cross Slope (%) | N/A |

Remove & Replace Gutter.

R304.5.4, STD 1115
