# Access Compliance Report Public Rights-of-Way (Curb Ramps)

Main Street: OLD\_FOOTHILL\_BLVDCross Street: FOOTHILL\_BLVDCLocation: NE

ADA ID: RPRK211011170515Ramp Type:Type 1 - Perpendicular Diagonal Initial Pass/Fail: PassOverall Compliance: NoSeverity Score: 0

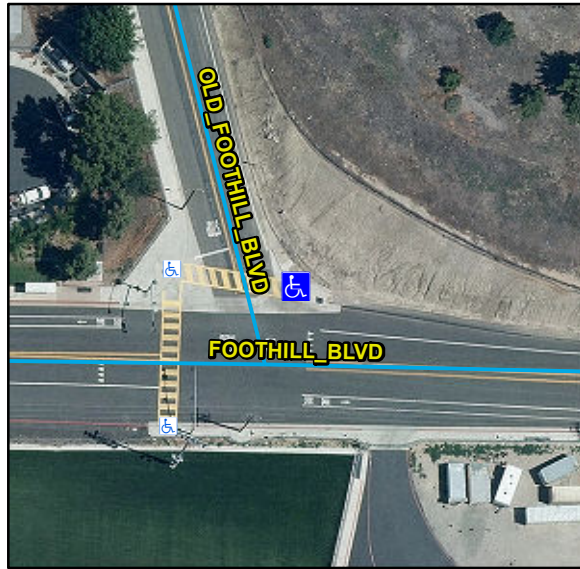
| Compliance | Description | Data | Compliance | Description | Data |
|---|---|---|---|---|---|
| No | Landing Run Slope (%) | 4.6 | N/A | Flare Traversable RT | Yes |
| No | Gutter Ponding | Yes | Yes | Curb Slope | 4.8 |

Remove & Replace Landing. Gutter Ponding Observed.
