# Access Compliance Report Public Rights-of-Way (Curb Ramps)

Main Street: Foothill\_BlvD Cross Street: Old\_Foothill\_BlvD Location: NW

ADA ID: RPRK211011170926 Ramp Type:Type 1 - Perpendicular Diagonal Initial Pass/Fail: Fail Overall Compliance: No Severity Score: 15

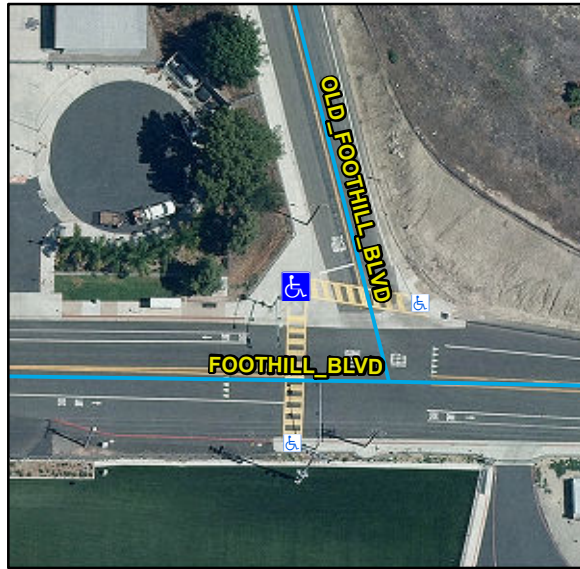
| Compliance | Description | Data | Compliance | Description | Data |
|---|---|---|---|---|---|
| No | Ramp Cross Slope (%) | 6 | N/A | Flare Traversable LT | N/A |

Remove & Replace Curb Ramp With Two New Directional Ramps or Equivalent.

R304.2.2, R204.3, R304.5.3, STD 1115
