# Access Compliance Report Public Rights-of-Way (Curb Ramps)

| Main Street: Foothill_BlvD | | Cross Street: Old_Foothill_BlvD | | Location: | SW |
| ADA ID: RPRK211011171900 | Ramp Type: Type 4 - Parallel | Initial Pass/Fail: Fail | Overall Compliance: No | Severity Score: | 15 |

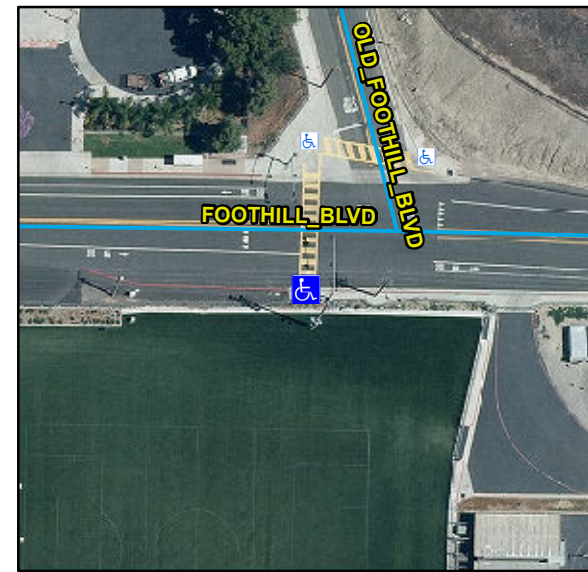
| Compliance | Description | Data | Compliance | Description | Data |
|---|---|---|---|---|---|
| No | Ramp Run Slope LT (%) | 11.1 | Yes | Ramp Run Slope RT (%) | 0.6 |

Possible Solutions:

Remove & Replace Entire Ramp.

R304.3.2, STD 1115

Total Cost: \$ 2000
