# Access Compliance Report Public Rights-of-Way (Curb Ramps)

Main Street: AFTON\_LN Cross Street: SE\_SKYLINE\_DR Location: SE

ADA ID: RPRK211012113456 Ramp Type: Type 6 - Directional 1 Initial Pass/Fail: Pass Overall Compliance: No Severity Score: 6

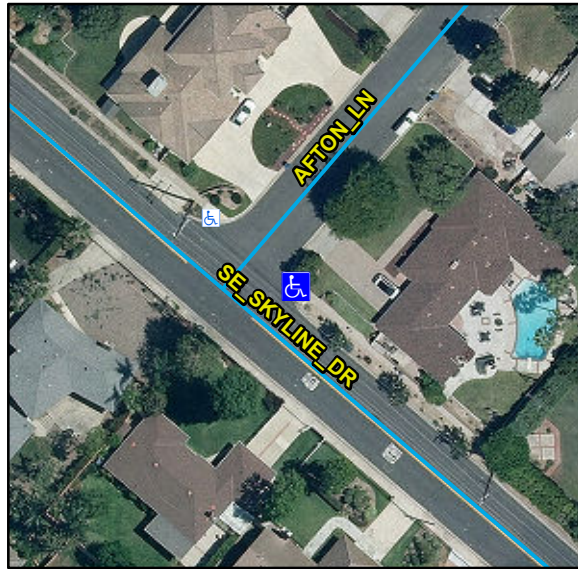
| Compliance | Description | Data | Compliance | Description | Data |
|---|---|---|---|---|---|
| No | Landing Run Slope (%) | 2.4 | | DWS Offset Type | Single |
| No | Gutter Run Slope (%) | 10.2 | | Road Cross Slope (%) | N/A |

Remove & Replace Landing. Remove & Replace Gutter.
