# Access Compliance Report Public Rights-of-Way (Curb Ramps)

| Main Street: RED_HILL_AVE | | Cross Street: SE_SKYLINE_DR | | Location: | NW |
| ADA ID: RPRK211012114301 | Ramp Type: Type 4 - Parallel | Initial Pass/Fail: Fail | Overall Compliance: No | Severity Score: | 15 |

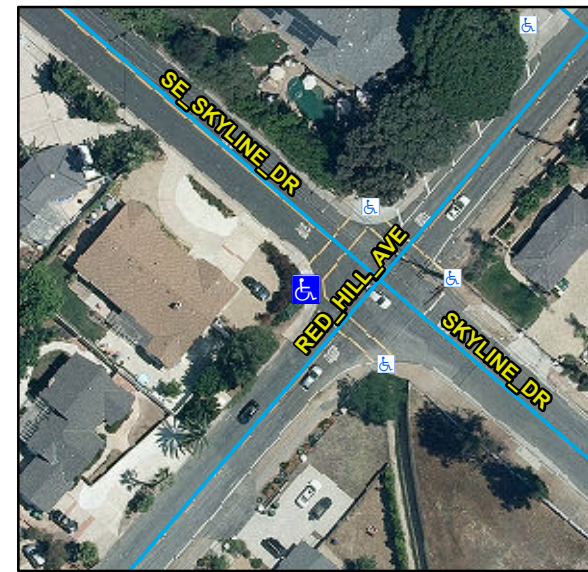
| Compliance | Description | Data | Compliance | Description | Data |
|---|---|---|---|---|---|
| Yes | Ramp Run Slope LT (%) | 6.2 | No | Ramp Run Slope RT (%) | 8.8 |

**Remove & Replace Curb Ramp With Two New Directional Ramps or Equivalent.**

**R304.3.2, STD 1115**
