# Access Compliance Report Public Rights-of-Way (Curb Ramps)

Main Street: COUNTRY\_LN Cross Street: SKYLINE\_DR Location: N

ADA ID: RPRK211012114926 Ramp Type: Type 7 - Directional 2 Initial Pass/Fail: Fail Overall Compliance: No Severity Score: 2

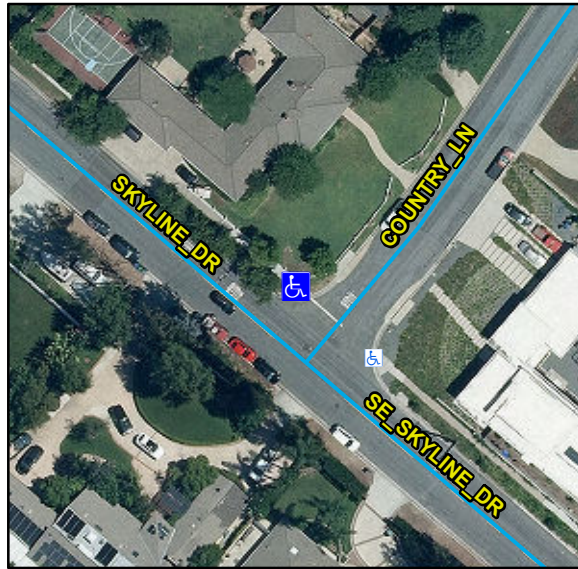
| Compliance | Description | Data | Compliance | Description | Data |
|---|---|---|---|---|---|
| No | Ramp Cross Slope (%) | 2.6 | N/A | Flare Traversable LT | N/A |

Possible Solutions:

Remove & Replace Entire Ramp.

R304.5.3, STD 1115

Total Cost: \$ 3080
