Access Compliance Report Public Rights-of-Way (Curb Ramps)

Main Street: COUNTRY_LN **Cross Street:** SE_SKYLINE_DR **Location:** E

ADA ID: RPRK211012115048 **Ramp Type:** Type 6 - Directional 1 **Initial Pass/Fail:** Pass **Overall Compliance:** No **Severity Score:** 15

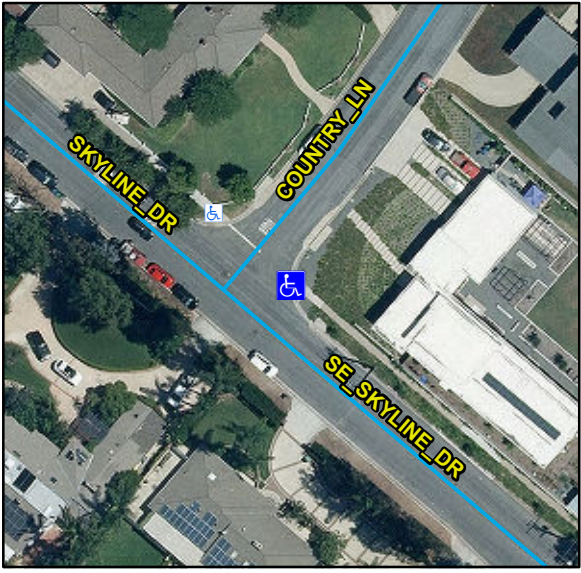
Compliance	Description	Data	Compliance	Description	Data
N/A	Ramp Length (in)	128	Yes	Flare Type LT	
Yes	Ramp Width (in)	97			Curbed2
Yes	Ramp Run Slope (%)	6.4	N/A	Flare Slope LT (%)	N/A
Yes	Ramp Cross Slope (%)	0.2	N/A	Flare Traversable LT	N/A
No	Grade Break	No	N/A	Flare Type RT	
N/A	Grade Break Slope (%)	N/A			Sloped
N/A	Grade Break Cross Slope (%)	N/A	N/A	Flare Slope RT (%)	7.2
	Addl Para Ramp Left?	No	N/A	Flare Traversable RT	No
	Addl Para Ramp Right?	No	No	DWS Provided	No
N/A	Landing Present	Yes	N/A	DWS Contrast	N/A
Yes	Landing Length (in)	110	N/A	DWS Length (in)	N/A
Yes	Landing Width (in)	48	N/A	DWS Full Width	N/A
Yes	Landing Run Slope (%)	0.5		DWS Offset Type	N/A
Yes	Landing Cross Slope (%)	0.9	N/A	DWS Left Offset (in)	N/A
N/A	Landing Movement Obstructed?	No	N/A	DWS Right Offset (in)	N/A
	Landing Movement Type	N/A			
N/A	Landing Shared	No			
N/A	Marked Crosswalk 1	No	N/A	Clear Space	N/A
	Crossing 1 Direction	NW	N/A	Clear Space To Crosswalk (in)	N/A

Marked Crosswalk 1 Width (in)	N/A			
N/A	Ramp Inside Crosswalk 1	N/A			
	Crossing 1 Slope (%)	1.2			
	Crossing 1 Cross Slope (%)	1.6			
Yes	Gutter Ponding	No	Yes	Curb Slope	5.4
Yes	Gutter Lip Height (in)	0		Road Run Slope (%)	N/A
No	Gutter Run Slope (%)	6.2		Road Cross Slope (%)	N/A
Yes	Gutter Cross Slope (%)	1.4		Parallel Ramp Side	Right
Yes	Overall Surface Condition	Acceptable	Yes	Perp Joint Present	Yes
	Cross Gutter Present?	No		Spandrel Present?	No
	Replace Cross Gutter?	N/A		Replace Spandrel?	N/A

Possible Solutions:
Remove & Replace Entire Ramp. Remove & Replace Gutter.

OC Std/PROW:
R304.5.2, R305, R304.5.4, STD 1115
