# Access Compliance Report Public Rights-of-Way (Curb Ramps)

| Main Street: SKYWAY_DR | | Cross Street: SE_SKYLINE_DR | | Location: | NE |
| ADA ID: RPRK211012115430 | Ramp Type: Type 7 - Directional 2 | Initial Pass/Fail: Fail | Overall Compliance: No | Severity Score: | 15 |

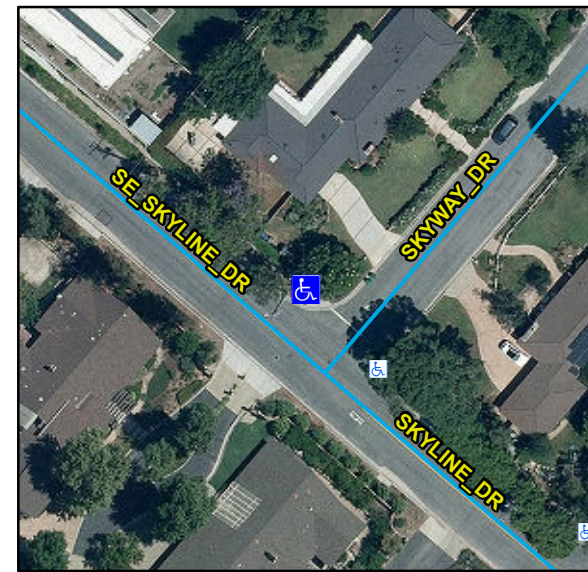
| Compliance | Description | Data | Compliance | Description | Data |
|---|---|---|---|---|---|
| No | Ramp Run Slope (%) | 8.4 | N/A | Flare Slope LT (%) | N/A |

Possible Solutions:

Remove & Replace Entire Ramp.

R304.2.2, STD 1115
