# Access Compliance Report Public Rights-of-Way (Curb Ramps)

Main Street: WYNDHAM COURT RD Cross Street: RED HILL AVE Location: S

ADA ID: RPRK211012121008 Ramp Type: Type 6 - Directional 1 Initial Pass/Fail: Pass Overall Compliance: No Severity Score: 50

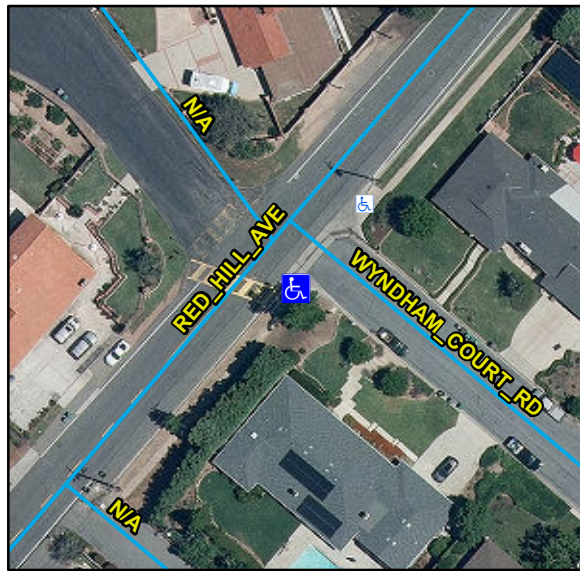
| Compliance | Description | Data | Compliance | Description | Data |
|---|---|---|---|---|---|
| No | Ramp Cross Slope (%) | 8.9 | N/A | Flare Traversable LT | N/A |
| No | Landing Run Slope (%) | 10.3 | | DWS Offset Type | N/A |
| No | Gutter Run Slope (%) | 11.9 | | Road Cross Slope (%) | N/A |
| No | Gutter Cross Slope (%) | 9 | | Parallel Ramp Side | Right |

Remove & Replace Entire Ramp. Remove & Replace Gutter.
