# Access Compliance Report Public Rights-of-Way (Curb Ramps)

Main Street: RED\_HILL\_AVE Cross Street: WYNDHAM\_COURT\_RD Location: SE

ADA ID: RPRK211012121342 Ramp Type: Type 7 - Directional 2 Initial Pass/Fail: Fail Overall Compliance: No Severity Score: 45

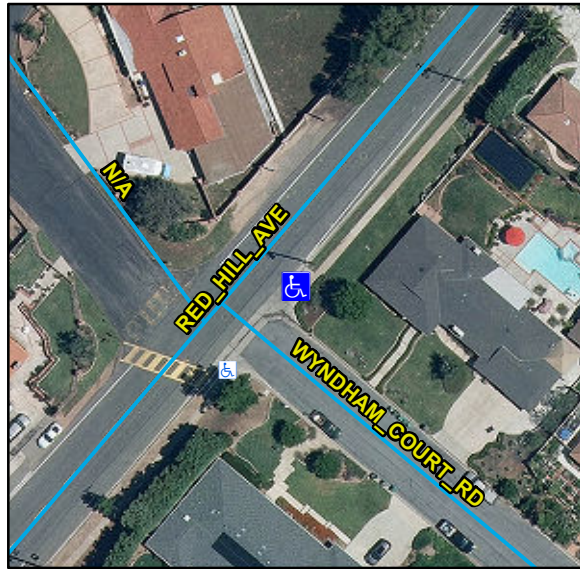
| Compliance | Description | Data | Compliance | Description | Data |
|---|---|---|---|---|---|
| No | Ramp Run Slope (%) | 14.6 | N/A | Flare Slope LT (%) | N/A |
| No | Ramp Cross Slope (%) | 5.3 | N/A | Flare Traversable LT | N/A |

Remove & Replace Entire Ramp.

R304.2.2, R304.5.3, STD 1115

Total Cost: \$ 3080
