# Access Compliance Report Public Rights-of-Way (Curb Ramps)

Main Street: Foothill\_BlvD Cross Street: Arroyo\_Ave Location: SW

ADA ID: RPRK211012121852 Ramp Type: Type 4 - Parallel Initial Pass/Fail: Fail Overall Compliance: No Severity Score: 4

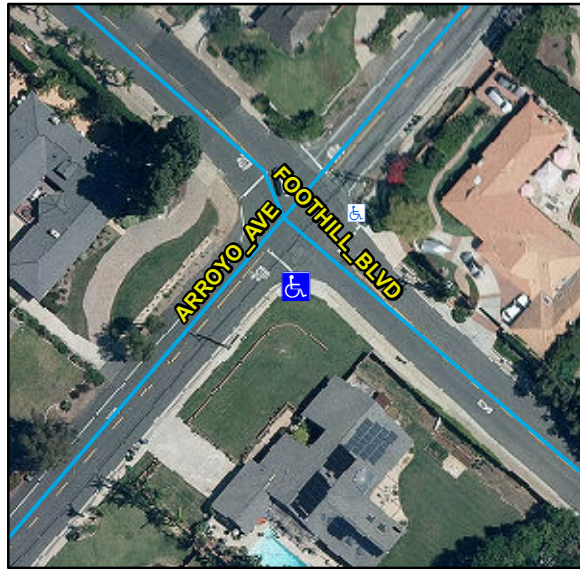
| Compliance | Description | Data | Compliance | Description | Data |
|---|---|---|---|---|---|
| Yes | Ramp Width LT (in) | 52 | No | Ramp Width RT (in) | 46 |

Remove & Replace Curb Ramp With Two New Directional Ramps or Equivalent.

R304.5.1, STD 1115
