# Access Compliance Report Public Rights-of-Way (Curb Ramps)

Main Street: RISA\_PL Cross Street: ARROYO\_AVE Location: S

ADA ID: RPRK211012122522 Ramp Type: Type 4 - Parallel Initial Pass/Fail: Fail Overall Compliance: No Severity Score: 30

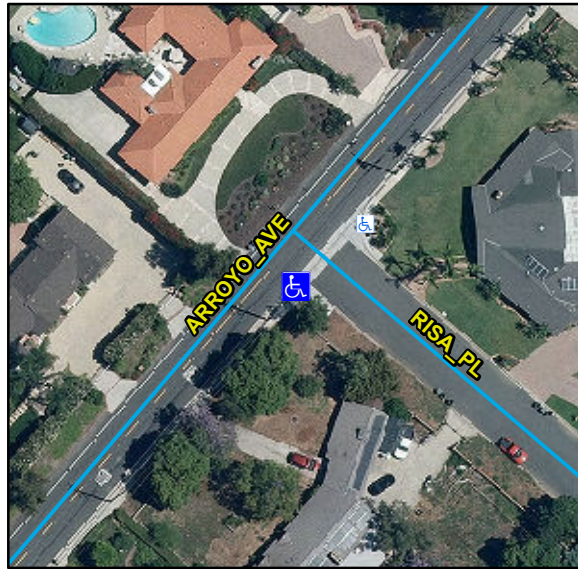
| Compliance | Description | Data | Compliance | Description | Data |
|---|---|---|---|---|---|
| No | Ramp Cross Slope LT (%) | 8.4 | No | Ramp Cross Slope RT (%) | 2.1 |

Remove & Replace Curb Ramp With Two New Directional Ramps or Equivalent.

R304.5.3, STD 1115
