# Access Compliance Report Public Rights-of-Way (Curb Ramps)

| Main Street: ARROYO_AVE | | Cross Street: RISA_PL | | Location: | E |
| ADA ID: RPRK211012122748 | Ramp Type: Type 4 - Parallel | Initial Pass/Fail: Fail | Overall Compliance: No | Severity Score: | 4 |

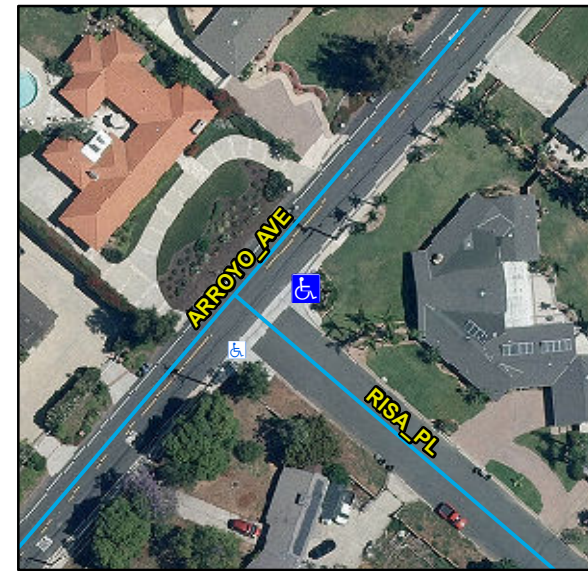
| Compliance | Description | Data | Compliance | Description | Data |
|---|---|---|---|---|---|
| No | Ramp Width LT (in) | 42 | No | Ramp Width RT (in) | 42 |
| Yes | Ramp Run Slope LT (%) | 8 | Yes | Ramp Run Slope RT (%) | 4.8 |
| Yes | Ramp Cross Slope LT (%) | 0.9 | Yes | Ramp Cross Slope RT (%) | 1.1 |

Possible Solutions:

**Remove & Replace Curb Ramp With Two New Directional Ramps or Equivalent.**

**R304.5.1, STD 1115**

Total Cost: \$ 4000
