# Access Compliance Report Public Rights-of-Way (Curb Ramps)

Main Street: HEATHCLIFF\_DR Cross Street: FOOTHILL\_BLVD Location: W

ADA ID: RPRK211012123256 Ramp Type: Type 4 - Parallel Initial Pass/Fail: Fail Overall Compliance: No Severity Score: 16

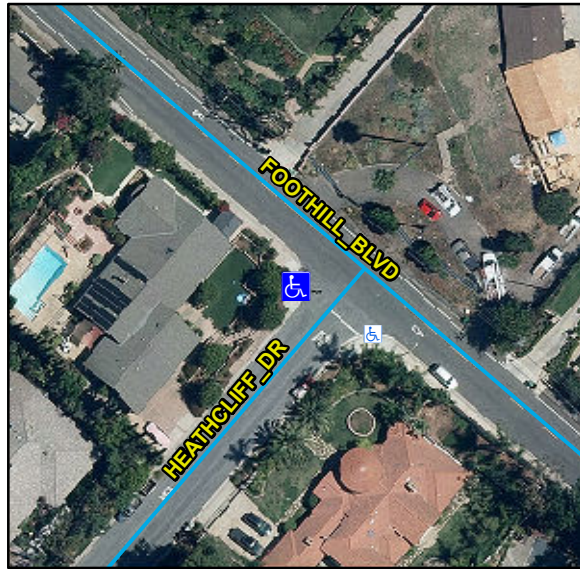
| Compliance | Description | Data | Compliance | Description | Data |
|---|---|---|---|---|---|
| No | Ramp Run Slope LT (%) | 11.8 | Yes | Ramp Run Slope RT (%) | 0.5 |
| Yes | Ramp Cross Slope LT (%) | 0.4 | No | Ramp Cross Slope RT (%) | 3.4 |

**Remove & Replace Curb Ramp With Two New Directional Ramps or Equivalent.**

**R304.3.2, R304.5.3, STD 1115**
