# Access Compliance Report Public Rights-of-Way (Curb Ramps)

Main Street: LA\_LOMA\_DR Cross Street: LOMA\_LINDA\_WAY Location: SW

ADA ID: RPRK211012124835 Ramp Type: Type 4 - Parallel Initial Pass/Fail: Pass Overall Compliance: No Severity Score: 20

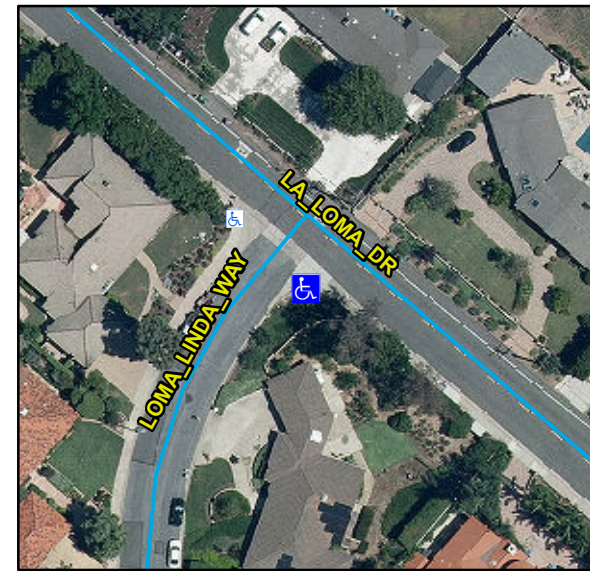
| Compliance | Description | Data | Compliance | Description | Data |
|---|---|---|---|---|---|
| N/A | Landing Present | No | No | DWS Provided | No |
| No | Landing Width (in) | N/A | N/A | DWS Length (in) | N/A |
| No | Landing Run Slope (%) | N/A | N/A | DWS Full Width | N/A |
| No | Landing Cross Slope (%) | N/A | | DWS Offset Type | N/A |

Possible Solutions:

**Remove & Replace Curb Ramp With Two New Directional Ramps or Equivalent.**
