# Access Compliance Report Public Rights-of-Way (Curb Ramps)

Main Street: LOMA\_LINDA\_WAY Cross Street: LA\_LOMA\_DR Location: W

ADA ID: RPRK211012125228 Ramp Type: Type 4 - Parallel Initial Pass/Fail: Fail Overall Compliance: No Severity Score: 2

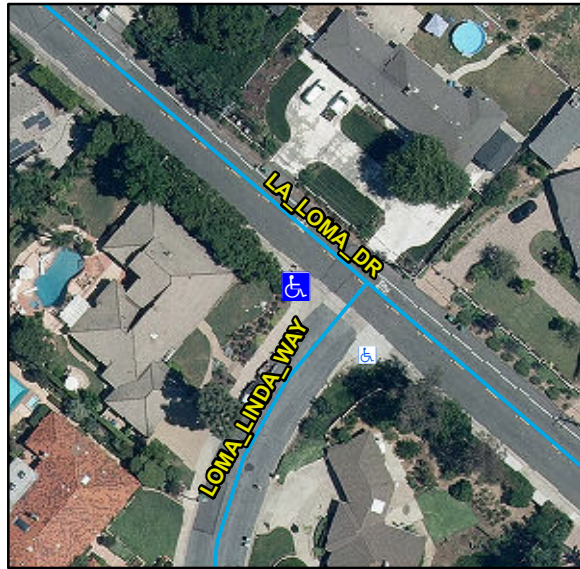
| Compliance | Description | Data | Compliance | Description | Data |
|---|---|---|---|---|---|
| No | Ramp Cross Slope LT (%) | 3.4 | No | Ramp Cross Slope RT (%) | 3 |

**Remove & Replace Curb Ramp With Two New Directional Ramps or Equivalent.**

**R304.5.3, STD 1115**
