# Access Compliance Report Public Rights-of-Way (Curb Ramps)

| Main Street: LA_LOMA_DR | | Cross Street: ARROYO_AVE | | Location: | S |
| ADA ID: RPRK211012125547 | Ramp Type: Type 4 - Parallel | Initial Pass/Fail: Fail | Overall Compliance: No | Severity Score: | 19 |

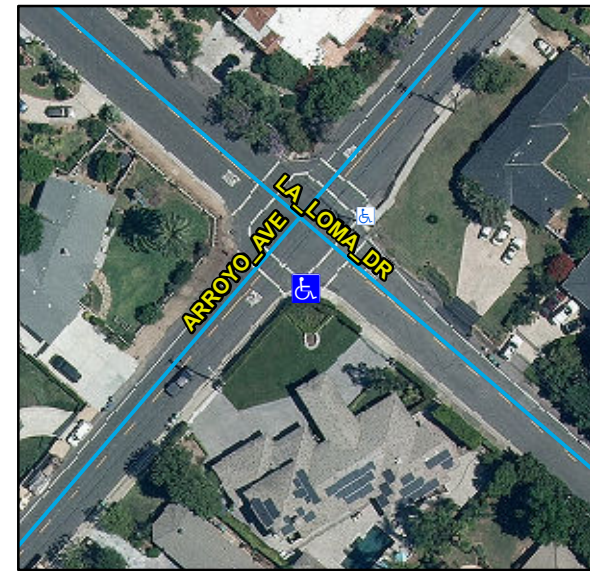
| Compliance | Description | Data | Compliance | Description | Data |
|---|---|---|---|---|---|
| No | Ramp Width LT (in) | 46 | No | Ramp Width RT (in) | 43 |
| No | Ramp Run Slope LT (%) | 8.7 | Yes | Ramp Run Slope RT (%) | 3.7 |

**Remove & Replace Curb Ramp With Two New Directional Ramps or Equivalent.**

**R304.5.1, R304.3.2, STD 1115**

Total Cost: \$ 4000
