# Access Compliance Report Public Rights-of-Way (Curb Ramps)

Main Street: CHADWICK\_LN Cross Street: MARBLE\_ARCH\_DR Location: SW

ADA ID: RPRK211012131137 Ramp Type: Type 7 - Directional 2 Initial Pass/Fail: Fail Overall Compliance: No Severity Score: 30

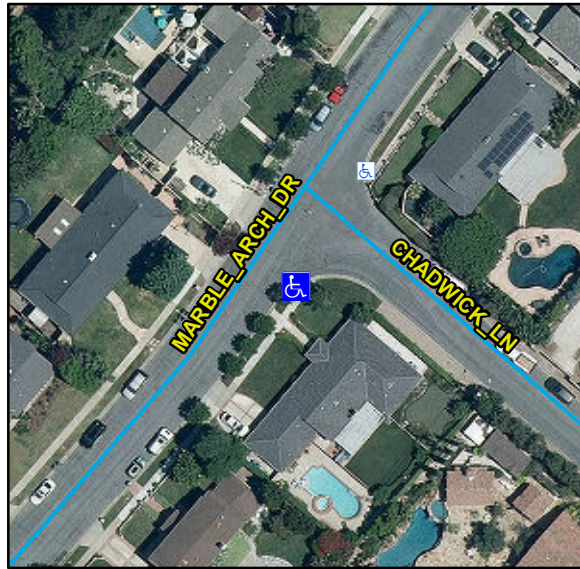
| Compliance | Description | Data | Compliance | Description | Data |
|---|---|---|---|---|---|
| No | Ramp Cross Slope (%) | 8 | N/A | Flare Traversable LT | N/A |

Remove & Replace Entire Ramp.

R304.5.3, STD 1115
