# Access Compliance Report Public Rights-of-Way (Curb Ramps)

Main Street: **BANBURY\_CROSS\_RD** Cross Street: **ARROYO\_AVE** Location: **E**

ADA ID: **RPRK211012131953** Ramp Type: **Type 6 - Directional 1** Initial Pass/Fail: **Pass** Overall Compliance: **No** Severity Score: **5**

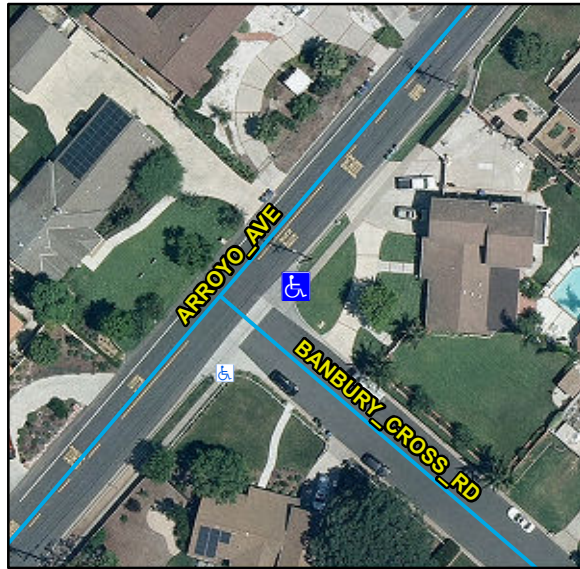
| Compliance | Description | Data | Compliance | Description | Data |
|---|---|---|---|---|---|
| <b>No</b> | Grade Break | <b>No</b> | <b>Yes</b> | Flare Type RT | |
| <b>Yes</b> | Gutter Ponding | <b>No</b> | <b>No</b> | Curb Slope | <b>14.4</b> |
| <b>No</b> | Gutter Run Slope (%) | <b>5.8</b> | | Road Cross Slope (%) | <b>N/A</b> |

**Remove & Replace Entire Ramp. Remove & Replace Gutter.**

**R304.2.2, R304.5.2, R304.5.4, STD 1115**
