# Access Compliance Report Public Rights-of-Way (Curb Ramps)

Main Street: BANBURY\_CROSS\_RD Cross Street: ARROYO\_AVE Location: S

ADA ID: RPRK211012132326 Ramp Type: Type 6 - Directional 1 Initial Pass/Fail: Pass Overall Compliance: No Severity Score: 5

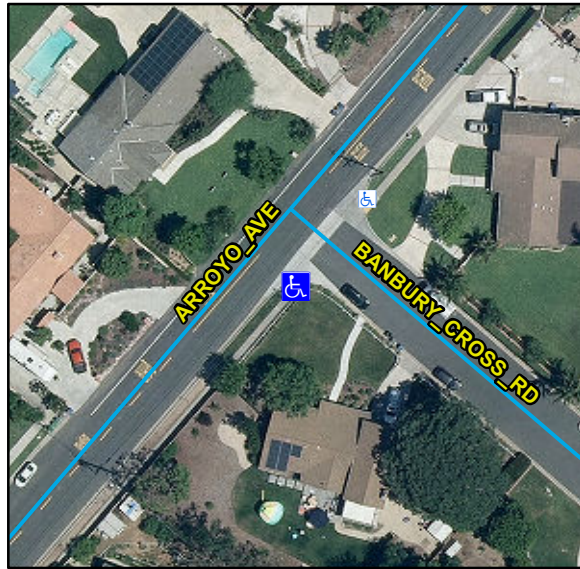
| Compliance | Description | Data | Compliance | Description | Data |
|---|---|---|---|---|---|
| No | Grade Break Slope (%) | 5.3 | | | Sloped |
| Yes | Gutter Ponding | No | No | Curb Slope | 12.2 |
| No | Gutter Run Slope (%) | 11.6 | | Road Cross Slope (%) | N/A |

Remove & Replace Entire Ramp. Remove & Replace Gutter.
