# Access Compliance Report Public Rights-of-Way (Curb Ramps)

| Main Street: RYCROFT_RD | | Cross Street: LA_LOMA_DR | | Location: | NW |
| ADA ID: RPRK211012133859 | Ramp Type:Type 1 - Perpendicular Diagonal Initial Pass/Fail: Fail | | Overall Compliance: No | Severity Score: | 16 |

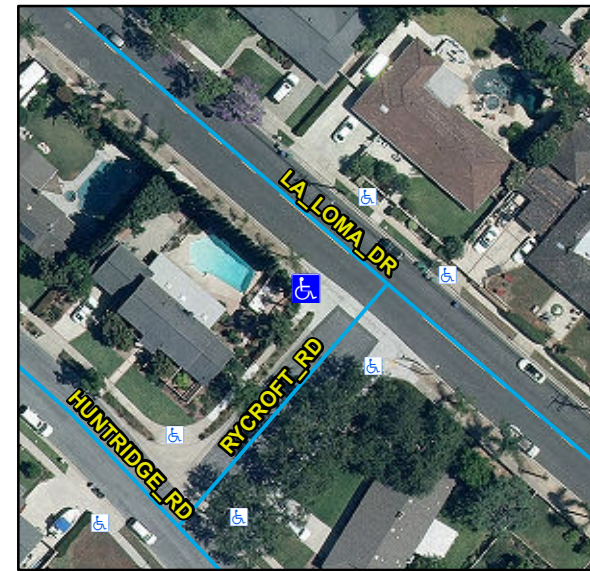
| Compliance | Description | Data | Compliance | Description | Data |
|---|---|---|---|---|---|
| No | Ramp Run Slope (%) | 11.8 | N/A | Flare Slope LT (%) | N/A |

**Remove & Replace Curb Ramp With Two New Directional Ramps or Equivalent.**

**R304.2.2, R204.3, STD 1115**
