# Access Compliance Report Public Rights-of-Way (Curb Ramps)

| Main Street: HUNTRIDGE_RD | | Cross Street: RYCROFT_RD | | Location: | NE |
| ADA ID: RPRK211012134322 | Ramp Type: Type 4 - Parallel | Initial Pass/Fail: Fail | Overall Compliance: No | Severity Score: | 15 |

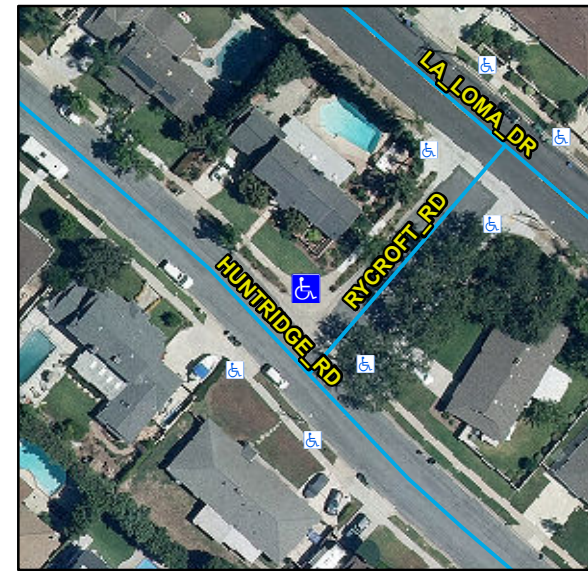
| Compliance | Description | Data | Compliance | Description | Data |
|---|---|---|---|---|---|
| Yes | Ramp Run Slope LT (%) | 3.3 | Yes | Ramp Run Slope RT (%) | 7 |
| No | Ramp Cross Slope LT (%) | 6.6 | No | Ramp Cross Slope RT (%) | 5.7 |

**Remove & Replace Curb Ramp With Two New Directional Ramps or Equivalent.**

**R204.3, R304.5.3, STD 1115**
