# Access Compliance Report Public Rights-of-Way (Curb Ramps)

Main Street: RYCROFT\_RD Cross Street: HUNTRIDGE\_RD Location: SE

ADA ID: RPRK211012134619 Ramp Type: Type 4 - Parallel Initial Pass/Fail: Fail Overall Compliance: No Severity Score: 30

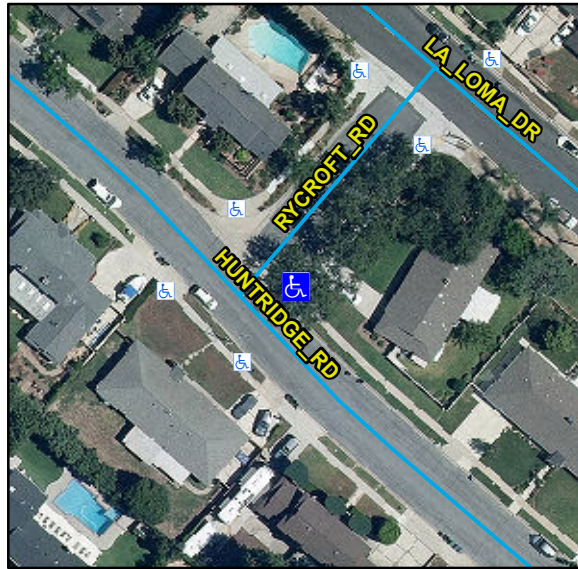
| Compliance | Description | Data | Compliance | Description | Data |
|---|---|---|---|---|---|
| No | Ramp Run Slope LT (%) | 9.3 | Yes | Ramp Run Slope RT (%) | 1.9 |
| No | Ramp Cross Slope LT (%) | 7 | No | Ramp Cross Slope RT (%) | 6.2 |

Remove & Replace Curb Ramp With Two New Directional Ramps or Equivalent.
