# Access Compliance Report Public Rights-of-Way (Curb Ramps)

Main Street: GREENWALD\_LN Cross Street: CRAWFORD\_CANYON\_RD Location: NE

ADA ID: RPRK211012141400 Ramp Type: Type 7 - Directional 2 Initial Pass/Fail: Pass Overall Compliance: No Severity Score: 15

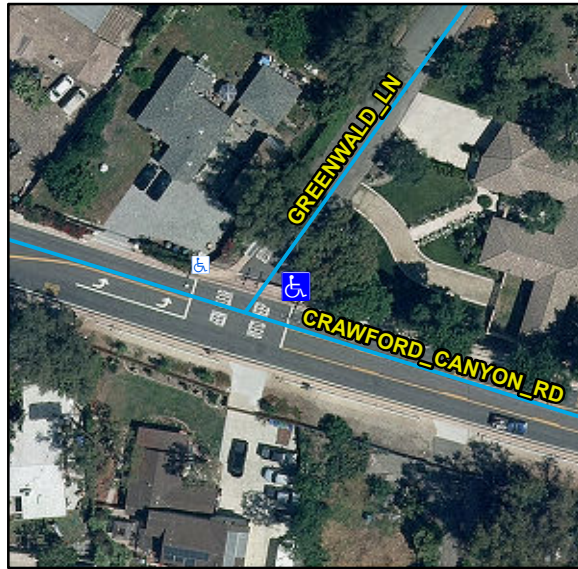
| Compliance | Description | Data | Compliance | Description | Data |
|---|---|---|---|---|---|
| Yes | Landing Width (in) | 48 | No | DWS Full Width | No |
| No | Landing Run Slope (%) | 6 | | DWS Offset Type | Multiple |
| Yes | Landing Cross Slope (%) | 0.7 | No | DWS Left Offset (in) | 70 |
| Yes | Gutter Ponding | No | No | Curb Slope | 8.7 |
| No | Gutter Run Slope (%) | 7.6 | | Road Cross Slope (%) | N/A |
| No | Gutter Cross Slope (%) | 9.4 | | Parallel Ramp Side | Left |

Remove & Replace Entire Ramp. Remove & Replace Gutter.
