# Access Compliance Report Public Rights-of-Way (Curb Ramps)

Main Street: GREENWALD\_LN Cross Street: CRAWFORD\_CANYON\_RD Location: NW

ADA ID: RPRK211012141744 Ramp Type: Type 7 - Directional 2 Initial Pass/Fail: Fail Overall Compliance: No Severity Score: 2

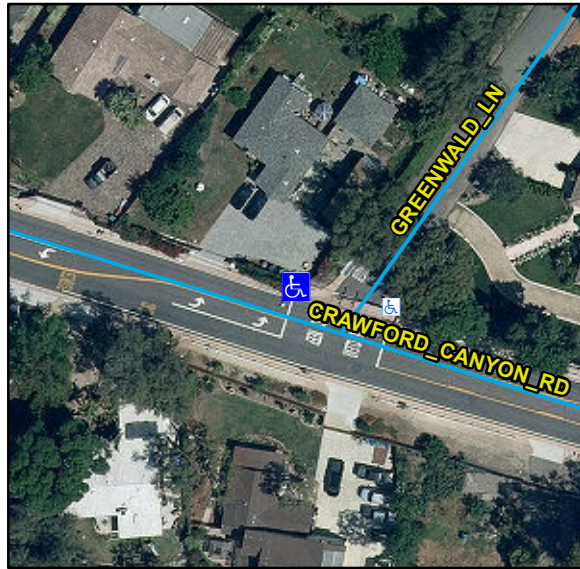
| Compliance | Description | Data | Compliance | Description | Data |
|---|---|---|---|---|---|
| No | Ramp Cross Slope (%) | 4.6 | N/A | Flare Traversable LT | N/A |

Remove & Replace Entire Ramp.

R304.5.3, STD 1115
