# Access Compliance Report Public Rights-of-Way (Curb Ramps)

| Main Street: N/A | | Cross Street: CRAWFORD_CANYON_RD | | Location: | NE |
| ADA ID: RPRK211012142315 | Ramp Type: Type 1 - Perpendicular | Initial Pass/Fail: Pass | Overall Compliance: No | Severity Score: | 0 |

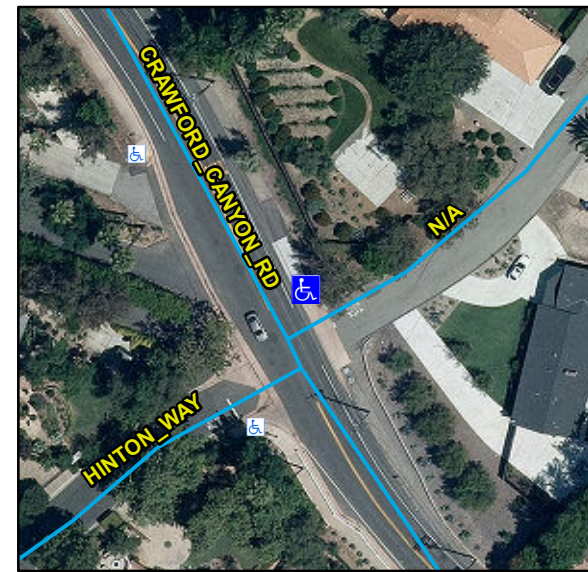
| Compliance | Description | Data | Compliance | Description | Data |
|---|---|---|---|---|---|
| No | Landing Run Slope (%) | 2.4 | N/A | Flare Traversable RT | N/A |

Remove & Replace Landing.
