# Access Compliance Report Public Rights-of-Way (Curb Ramps)

Main Street: CRAWFORD\_CANYON\_RD Cross Street: HINTON\_WAY Location: SW

ADA ID: RPRK211012142958 Ramp Type: Type 4 - Parallel Initial Pass/Fail: Fail Overall Compliance: No Severity Score: 2

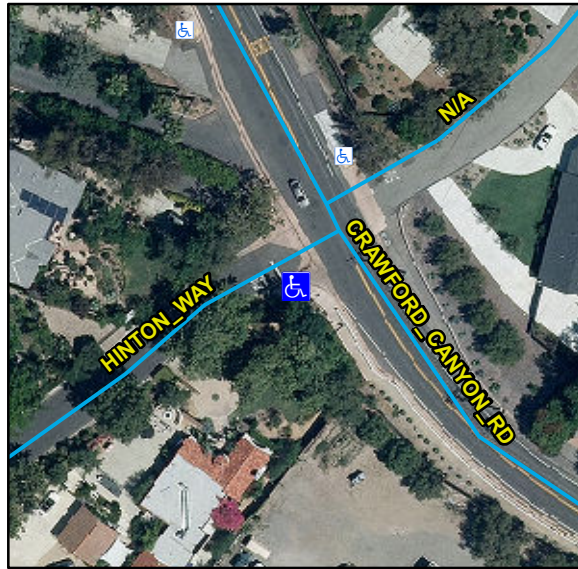
| Compliance | Description | Data | Compliance | Description | Data |
|---|---|---|---|---|---|
| No | Ramp Cross Slope LT (%) | 2.2 | Yes | Ramp Cross Slope RT (%) | 1.4 |

**Remove & Replace Curb Ramp With Two New Directional Ramps or Equivalent.**

**R304.5.3, STD 1115**
