Access Compliance Report Public Rights-of-Way (Curb Ramps)

Main Street: NEWPORT_BLV **Cross Street:** E_SKYLARK_PL **Location:** W

ADA ID: RPRK211012144218 **Ramp Type:** Type 4 - Parallel **Initial Pass/Fail:** Fail **Overall Compliance:** No **Severity Score:** 15

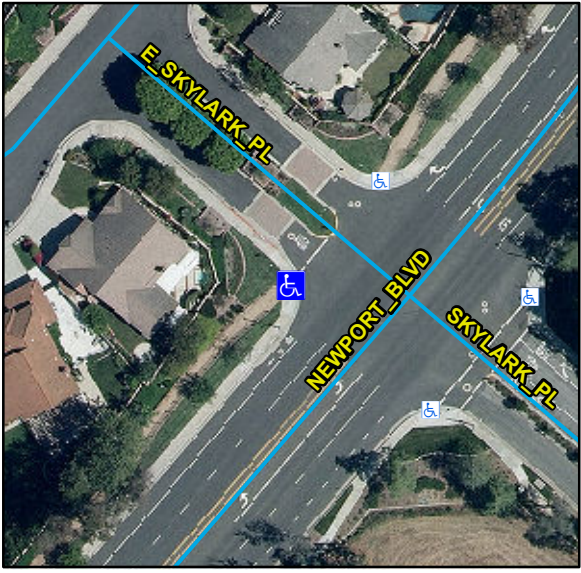
Compliance	Description	Data	Compliance	Description	Data
N/A	Ramp Length LT (in)	135	N/A	Ramp Length RT (in)	114
Yes	Ramp Width LT (in)	80	Yes	Ramp Width RT (in)	77
No	Ramp Run Slope LT (%)	10.9	Yes	Ramp Run Slope RT (%)	2.5
Yes	Ramp Cross Slope LT (%)	1.1	Yes	Ramp Cross Slope RT (%)	0.2
N/A	Landing Present	N/A	N/A	DWS Provided	N/A
N/A	Landing Length (in)	N/A	N/A	DWS Contrast	N/A
N/A	Landing Width (in)	N/A	N/A	DWS Length (in)	N/A
N/A	Landing Run Slope (%)	N/A	N/A	DWS Full Width	N/A
N/A	Landing Cross Slope (%)	N/A		DWS Offset Type	N/A
N/A	Landing Movement Obstructed?	N/A	N/A	DWS Offset Left (in)	N/A
	Landing Movement Type	N/A	N/A	DWS Offset Right (in)	N/A
N/A	Landing Shared	N/A			
N/A	Clear Space	Yes			
N/A	Clear Space To Crosswalk (in)	N/A			
N/A	Marked Crosswalk 1	No	N/A	Marked Crosswalk 2	No
	Crossing 1 Direction	SE		Crossing 2 Direction	NE
N/A	Marked Crosswalk 1 Width (in)	N/A		Marked Crosswalk 2 Width (in)	N/A

N/A	Ramp Inside Crosswalk 1	N/A	N/A	Ramp Inside Crosswalk 2	N/A
	Crossing 1 Slope (%)	3.3		Crossing 2 Slope (%)	4.5
	Crossing 1 Cross Slope (%)	6.6		Crossing 2 Cross Slope (%)	1.9
N/A	Gutter Ponding	N/A	N/A	Curb Slope	9.4
Yes	Gutter Lip Height (in)	0		Road Run Slope (%)	6.1
N/A	Gutter Run Slope (%)	N/A		Road Cross Slope (%)	5
N/A	Gutter Cross Slope (%)	N/A	Yes	Perpendicular Joint Present	Yes
Yes	Overall Surface Condition	Acceptable			
	Cross Gutter Present?	No		Spandrel Present?	No
	Replace Cross Gutter?	N/A		Replace Spandrel?	N/A

Possible Solutions:
Remove & Replace Curb Ramp With Two New Directional Ramps or Equivalent.
