# Access Compliance Report Public Rights-of-Way (Curb Ramps)

Main Street: SKYLARK\_PL Cross Street: SKYLARK\_PL Location: SW

ADA ID: RPRK211012144514 Ramp Type: Type 4 - Parallel Initial Pass/Fail: Fail Overall Compliance: No Severity Score: 16

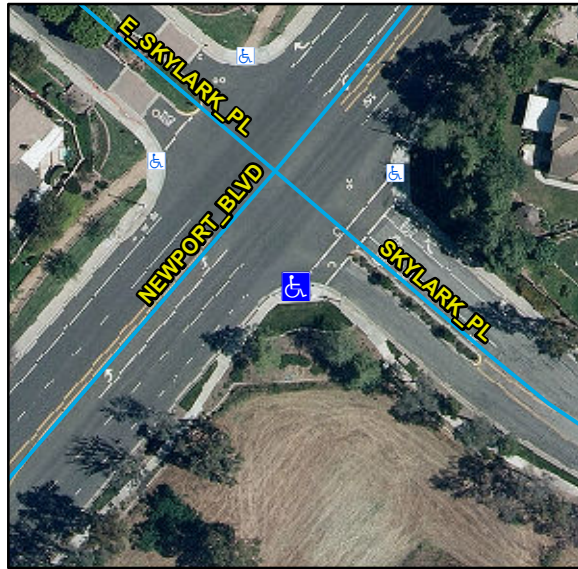
| Compliance | Description | Data | Compliance | Description | Data |
|---|---|---|---|---|---|
| Yes | Ramp Run Slope LT (%) | 2.9 | No | Ramp Run Slope RT (%) | 9.3 |
| No | Ramp Cross Slope LT (%) | 2.3 | Yes | Ramp Cross Slope RT (%) | 1.3 |

Remove & Replace Curb Ramp With Two New Directional Ramps or Equivalent.

R304.5.3, R304.3.2, STD 1115

Total Cost: \$ 4000
