# Access Compliance Report Public Rights-of-Way (Curb Ramps)

Main Street: GREENBRIER\_RD Cross Street: NEWPORT\_BLV Location: N

ADA ID: RPRK211012145312 Ramp Type: Type 4 - Parallel Initial Pass/Fail: Fail Overall Compliance: No Severity Score: 16

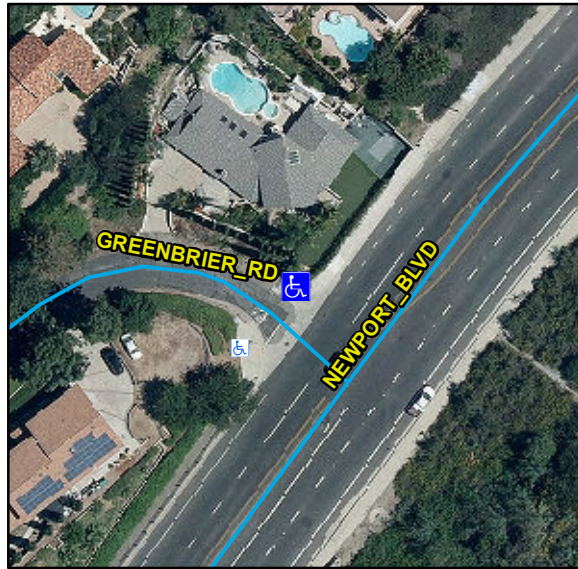
| Compliance | Description | Data | Compliance | Description | Data |
|---|---|---|---|---|---|
| No | Ramp Run Slope LT (%) | 10.8 | No | Ramp Run Slope RT (%) | 9.8 |
| No | Ramp Cross Slope LT (%) | 3 | Yes | Ramp Cross Slope RT (%) | 2 |

Remove & Replace Curb Ramp With Two New Directional Ramps or Equivalent.

R304.3.2, R304.5.3, STD 1115
