# Access Compliance Report Public Rights-of-Way (Curb Ramps)

Main Street: NEWPORT\_BLV D Cross Street: GREENBRIER\_RD Location: W

ADA ID: RPRK211012145620 Ramp Type:Type 1 - Perpendicular Diagonal Initial Pass/Fail: Fail Overall Compliance: No Severity Score: 2

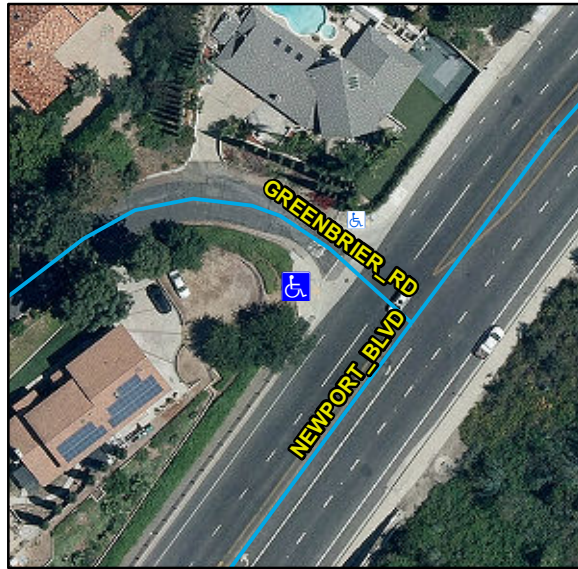
| Compliance | Description | Data | Compliance | Description | Data |
|---|---|---|---|---|---|
| No | Ramp Cross Slope (%) | 4.6 | N/A | Flare Traversable LT | N/A |

Remove & Replace Curb Ramp With Two New Directional Ramps or Equivalent.

R304.5.3, STD 1115
