# Access Compliance Report Public Rights-of-Way (Curb Ramps)

Main Street: NEWPORT\_BLVD Cross Street: ROCKHURST\_ST Location: NW

ADA ID: RPRK211012150746 Ramp Type: Type 1 - Perpendicular Diagonal Initial Pass/Fail: Pass Overall Compliance: No Severity Score: 0

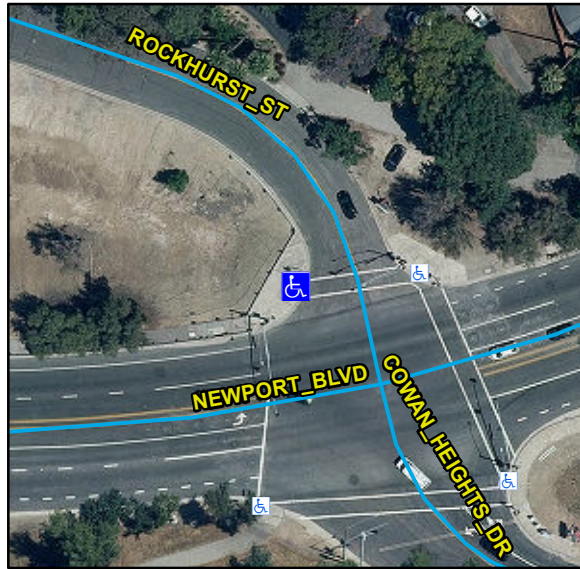
| Compliance | Description | Data | Compliance | Description | Data |
|---|---|---|---|---|---|
| Yes | Gutter Ponding | No | No | Curb Slope | 8.1 |

Remove & Replace Curb Slope.

R304.2.2, STD 1115
