# Access Compliance Report Public Rights-of-Way (Curb Ramps)

Main Street: ROCKHURST\_ST Cross Street: NEWPORT\_BLVD Location: NE

ADA ID: RPRK211012151715 Ramp Type: Type 1 - Perpendicular Diagonal Initial Pass/Fail: Fail Overall Compliance: No Severity Score: 2

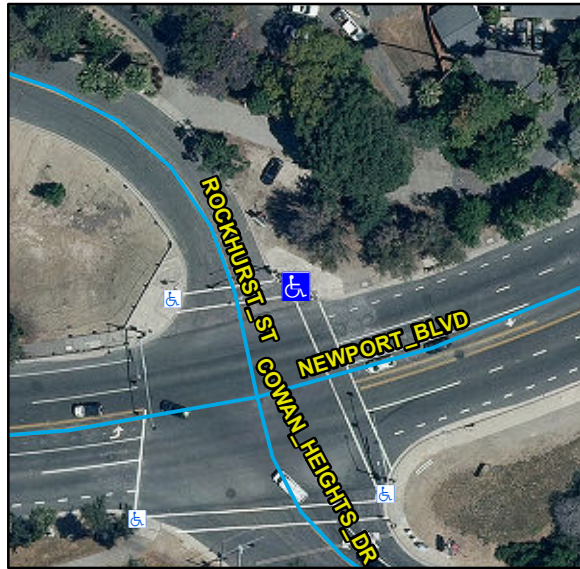
| Compliance | Description | Data | Compliance | Description | Data |
|---|---|---|---|---|---|
| No | Ramp Cross Slope (%) | 3 | N/A | Flare Traversable LT | N/A |
| Yes | Overall Surface Condition: Acceptable | | No | Perp Joint Present | No |

Remove & Replace Curb Ramp With Two New Directional Ramps or Equivalent.

R304.2.2, R204.3, R304.5.3, STD 1115
